2nd International Conference on Structural Integrity, ICSI 2017, 4-7 September 2017, Funchal, Madeira, Portugal

Analysis of the environmental degradation effects on the cables of “La Arena” bridge (Spain)

J.A. Álvarez^{a*}, R. Lacalle^{a,b}, B. Arroyo^a, J. Sainz-Aja^a, I. Sosa^a, C. Alonso^c

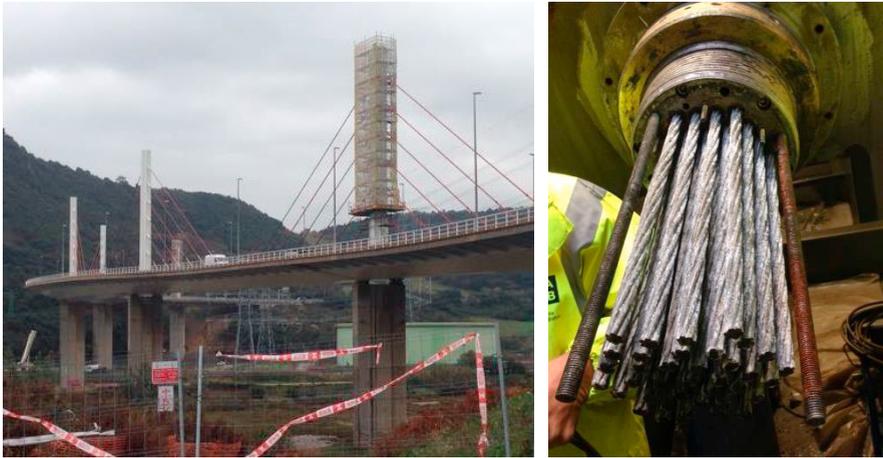
During a maintenance inspection of the bridge (see Figure 2), some fractured wires were detected. The fractures seemed to be linked to an environmental degradation process since some corrosion evidences –oxides and loss of material- were also observed. The fracture surfaces presented a quasi-planar typology (see Figure 3), with some apparently brittle features and some areas probably corresponding to fatigue crack growth. Loss of section also seems to have played a role in the failures as this type of defects are always present in the vicinity of fracture surfaces (see Figure 4). The reduction of area due to corrosion was between 10 and 20% for all the broken wires. The number of detected broken wires per strand was usually 2 or 3, being the central wire always undamaged. It is also important to notice that the original zinc-base protective coating is partially missing in some of these wires.

Fig. 2. Left: Bridge during inspection tasks; right: strands conforming one of the bridge's tendons during an inspection.

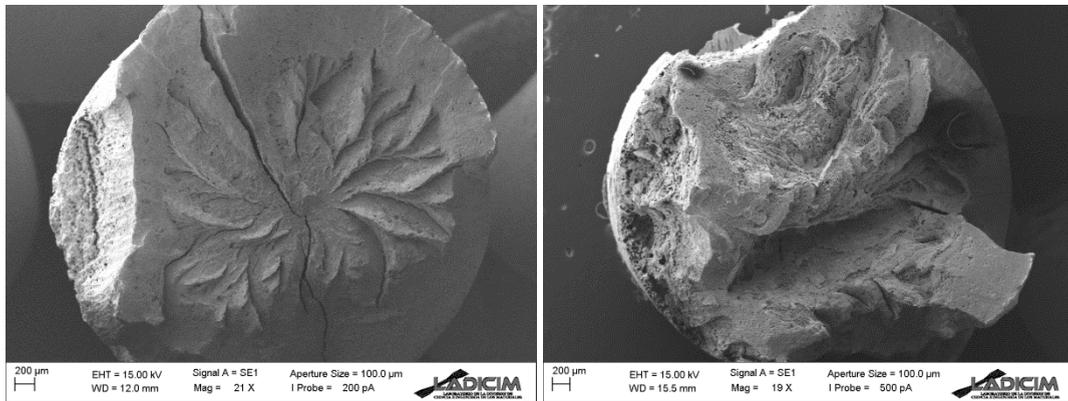
Fig. 3. Fracture surfaces of two of the broken wires detected during maintenance inspection of the bridge.

In view of these conclusions, two main remedial actions are recommended. First of them is the replacement of those strands with generalised corrosion in all their wires. The second is to control the environment and the humidity levels in order to preserve the properties of the galvanising layer as no fractured wires are expected if this coating is in good condition.

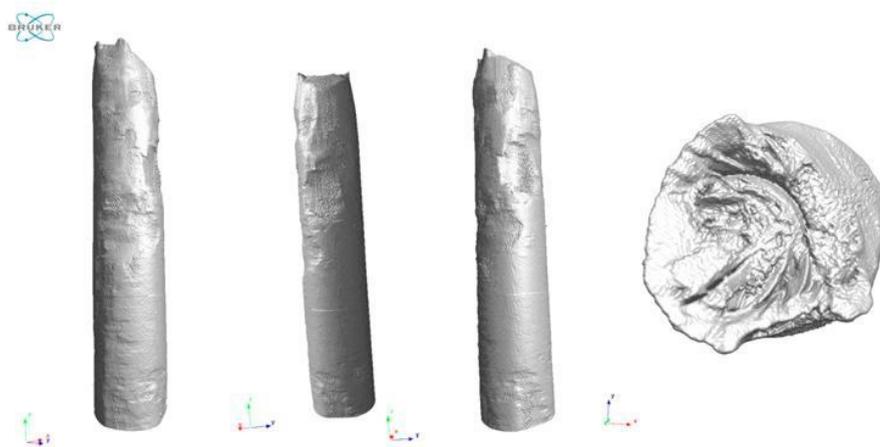
Fig. 4. Computerised Axial Tomography (ACT) image of a wire close to the fracture surface. Loss of material due to corrosion can be observed.

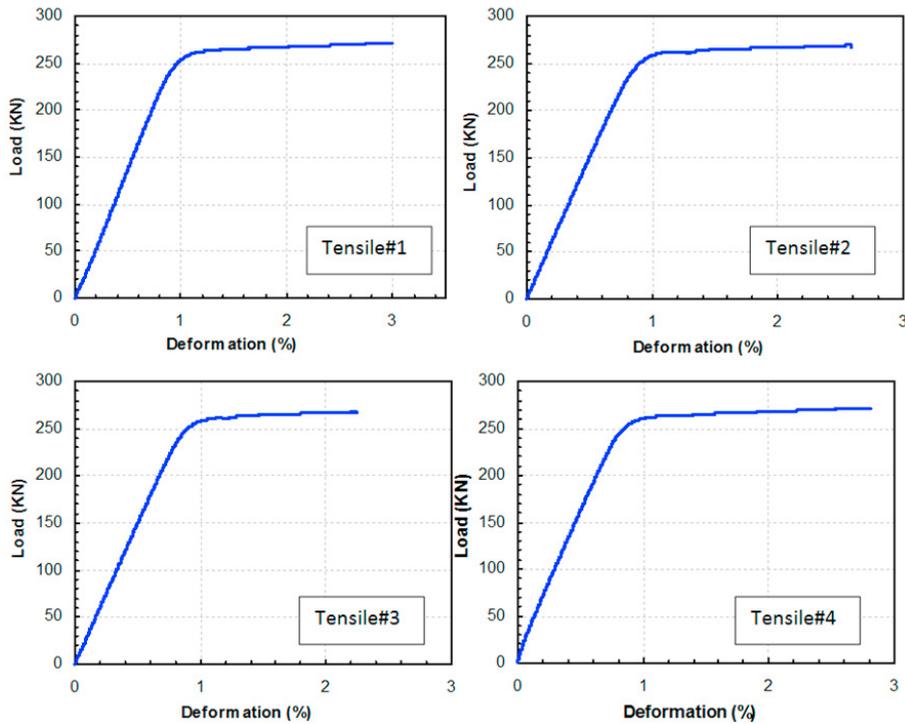
No one of the strands tested presented relatively large flaws, being all of them of low entity. Despite this fact, none of them fitted the standard requirements, presenting a rupture in one of its wires prior to reaching the minimum required breaking load or minimum required deformation.

Fig. 5. Load-Strain curves from tensile tests.

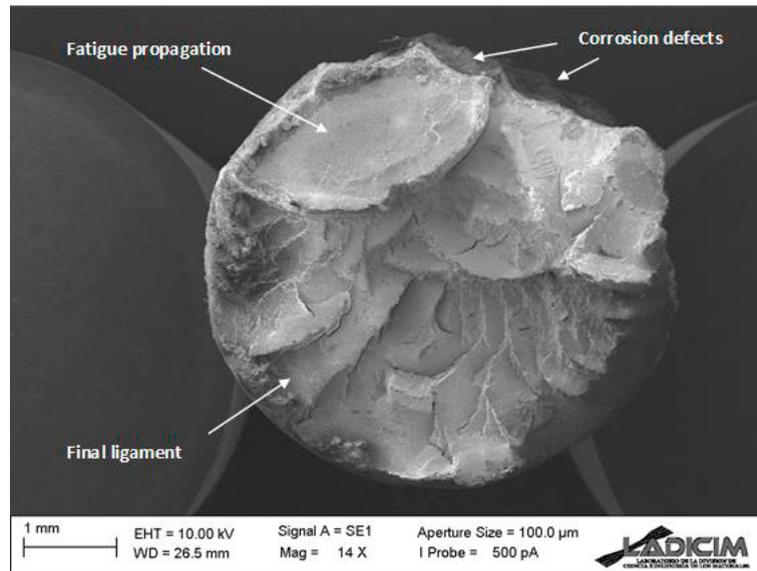
Figure 6 shows a SEM image of one of the broken wires of sample *Fatigue #3*. This sample has been taken as an example but all the fracture surfaces of the wires broken during the fatigue tests exhibit the same features. In Figure 6, 3 different regions can be observed:

- Corrosion defects (loss of section).
- Fatigue propagation area.
- Final fracture ligament.

It seems to be clear that the fatigue crack initiates from surface corrosion defects. These corrosion defects play the role of surface stress concentrators that reduce drastically the time needed for crack initiation in the fatigue process.

Fig. 6. SEM image of one of the broken wires of sample Fatigue #3.

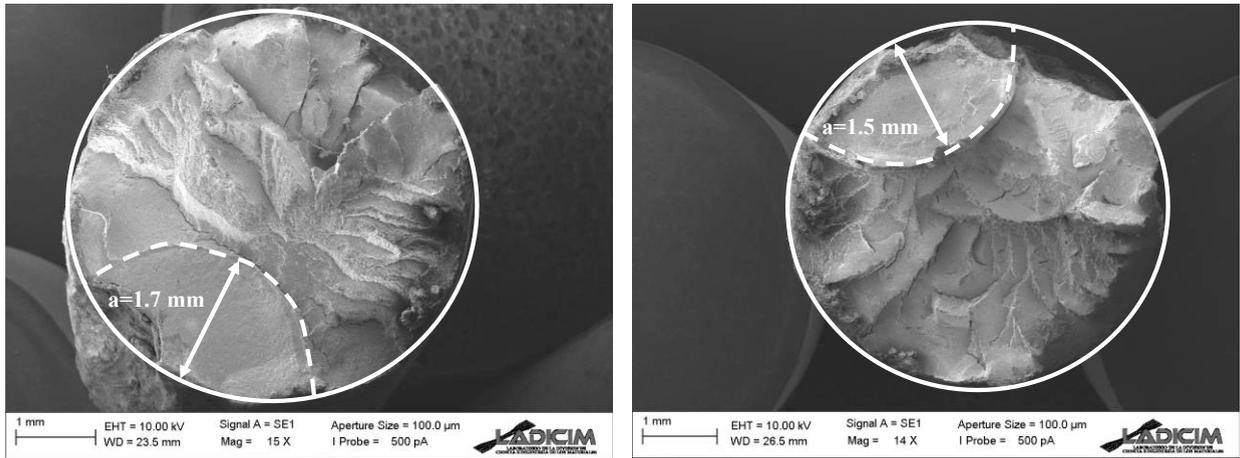
In the sample *Fatigue #3*, the extension of the fatigue crack in the two first broken wires can be clearly identified (Figure 7). The effective maximum load acting on each of the wires without any of them broken is 17.94 kN (total load divided by 7), while when one of the wires is broken the total load has to be distributed among the 6 unbroken wires, so then, the effective load on each element is 20.93 kN. Given that, the wire with a deeper crack –Wire #A– (Figure 7) is supposed to be the first suffering fracture.

Fig. 7. Broken wires of sample Fatigue #3. Left: Wire A; right: Wire B.

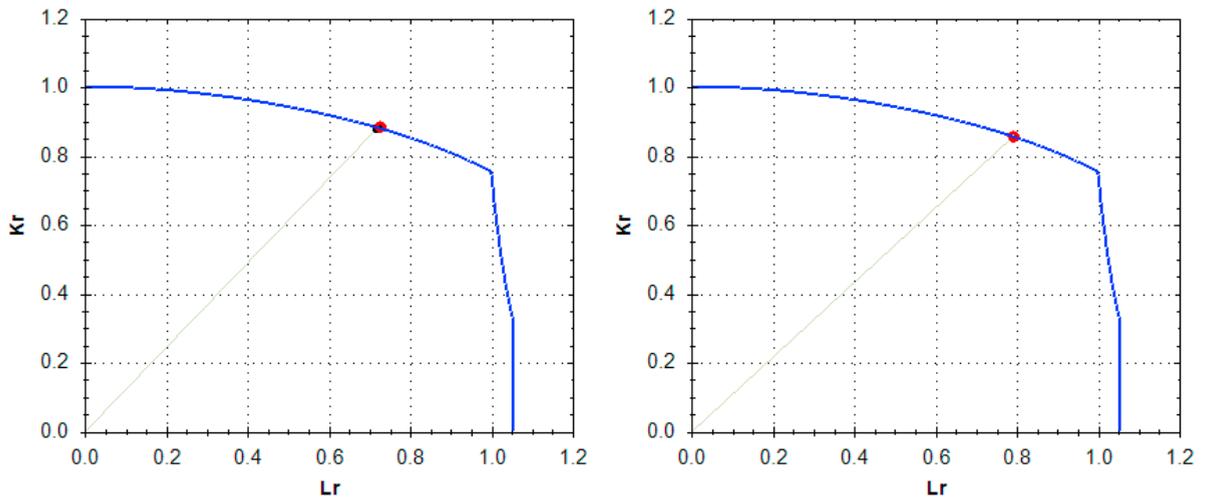
With these data –crack length and maximum applied load– a fracture assessment was performed using the procedures of BS7910:2013. In the analysis, Failure Assessment Diagrams (FAD) were used. As fracture toughness of the material, K_{mat} , was initially unknown the analysis consisted of searching a value for this parameter that made the assessment point lies exactly on the Failure Assessment Line (Figure 8). The values obtained for K_{mat} with the analysis were $80 \text{ MPa}\cdot\text{m}^{0.5}$ for Wire #A and $83 \text{ MPa}\cdot\text{m}^{0.5}$ for Wire #B. These values are in good agreement with the obtained by Toribio et al. (2006) for undamaged cables. These results means that, in spite of the high hydrogen contents detected in the wires, no evidences of embrittlement have been observed in fracture toughness values.

Fig. 8. FAD assessment of the wires of sample Fatigue #3. Left: Wire A; right: Wire B.

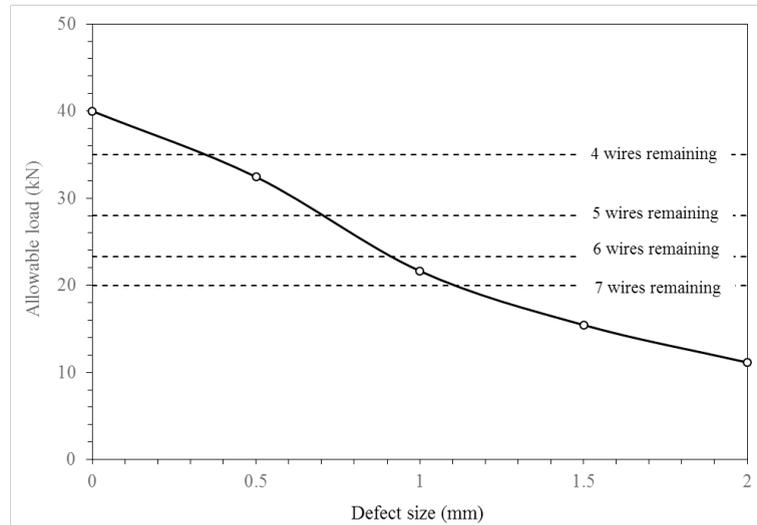
Following again the rules of BS7910:2013, a complementary structural integrity assessment was performed in order to determine the critical load value as a function of the corrosion defect size. In this analysis, according to the results of the previous section, a value for fracture toughness of $80 \text{ MPa}\cdot\text{m}^{0.5}$ was assumed. The corrosion defects were considered as cracks taking into account that stress corrosion cracking and fatigue (or environmental fatigue) cannot be discarded as degradation processes in the strands. A straight front crack was used in the analysis. In Figure 9 the relationship between allowable load (per wire) and critical defect size can be seen. With all the 7 wires of an strand working, the critical size of a defect for a typical working load of 50% of the nominal maximum load of the strand, was about 1.1 mm. This value decreases as the number of broken wires increases, but on the other side, the results show that, for the working conditions of the bridge, theoretically at least 5 wires must have corrosion damage before the collapse of the whole strand. The results of this analysis are in good agreement with the behavior observed in in-field failures.

Fig. 9. Allowable load vs. defect size.
