The Impact of Design on Material Corrosion: An Illustrative Example

In this paper, the synergy between corrosion and design is studied via an illustrative example: a relatively new, large footbridge, located in the north of Spain, which shows evident signs of corrosion.

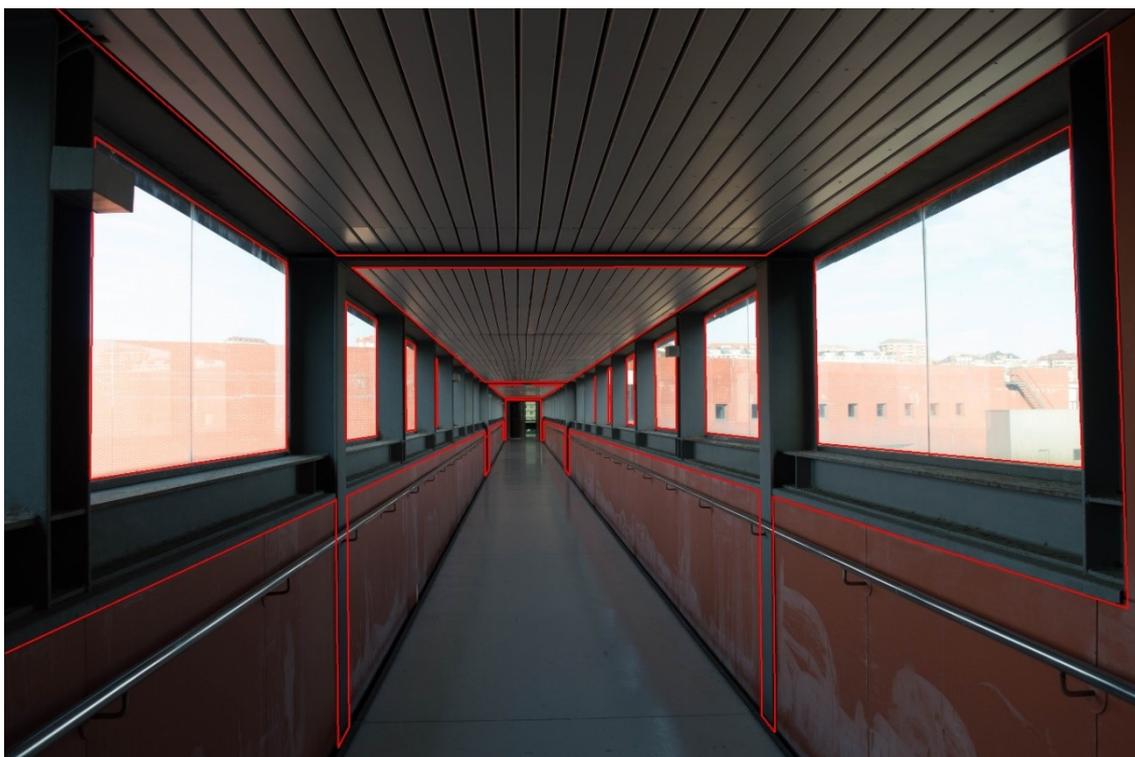
The footbridge has been in service for less than 25 years, yet it shows important signs of corrosion in its steel frame structure (Figures 2 and 3), as this phenomenon has not been appropriately considered during the design stage of the project. In addition to this, maintenance has not been carried out, aggravating the corrosion problems.

These corrosion problems are of high relevance, as they provoke that the structural capabilities of the steel frame are undermined, which can potentially cause the failure of the footbridge. The structural weakening is produced because, during the corrosion process, a part of the steel transforms into corrosion products and therefore reduces the effective section of the beam and, consequently, its mechanical properties.

Figure 2. Steel frame structure of the footbridge (outlined in red)

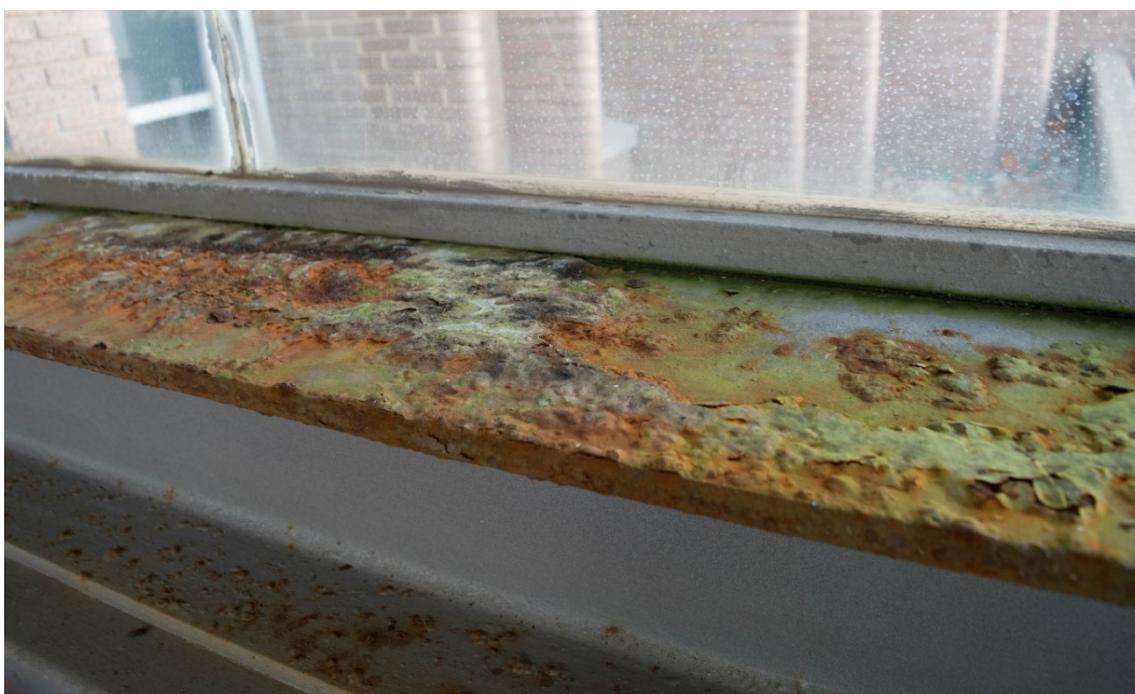
Figure 3. Corrosion damage in the footbridge structure

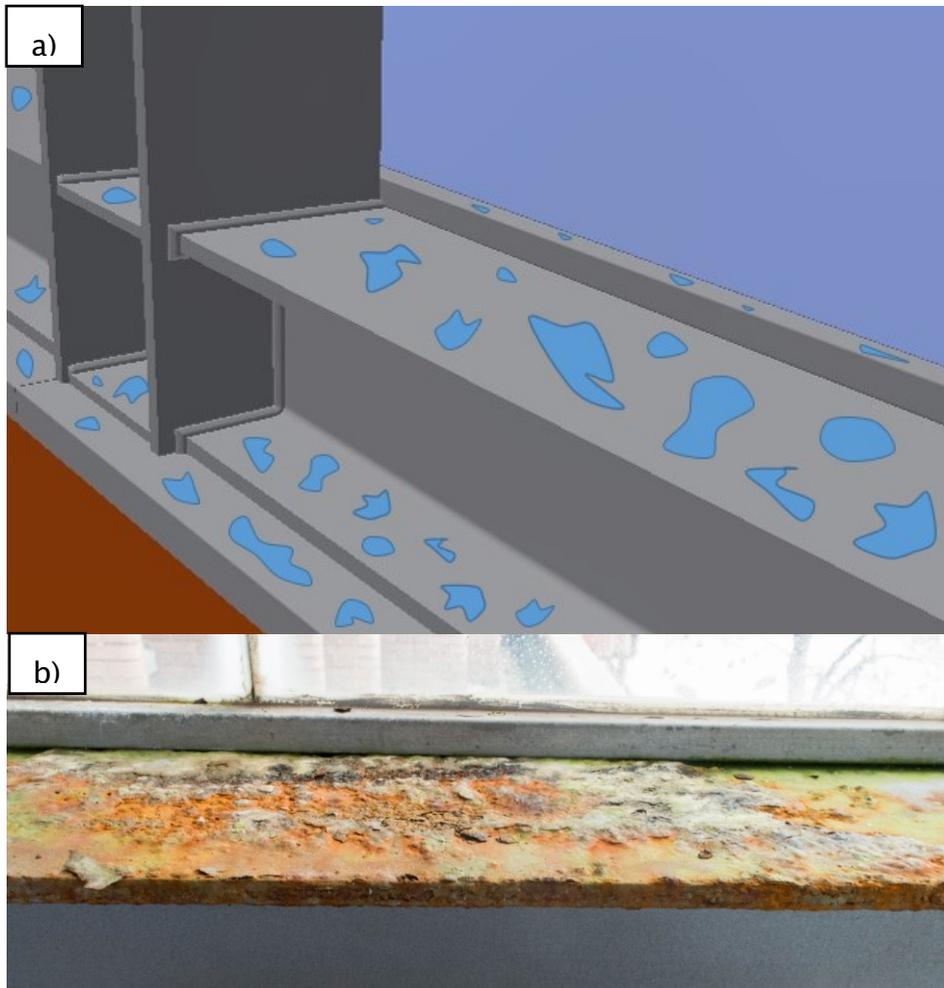
The structure presents a significant amount of horizontal surfaces, which difficult the drainage of the condensation liquid that drips from the windows. In Figure 4a, a schematic drawing of this problem is shown.

The retained liquid acts as the electrolyte for the corrosion reaction, which combined with the low quality of the protective coating, causes deterioration in the horizontal surfaces.

The corrosion damage caused by this phenomenon can be observed in the majority of the structure (Figure 4b).

Figure 4 (a, b). Corrosion issues in the horizontal surfaces

This design mistake cannot be solved geometrically without creating a great alteration in the initial design. For this reason, this complication will be addressed only with the previously mentioned long-lasting, high-quality, coating protocol.

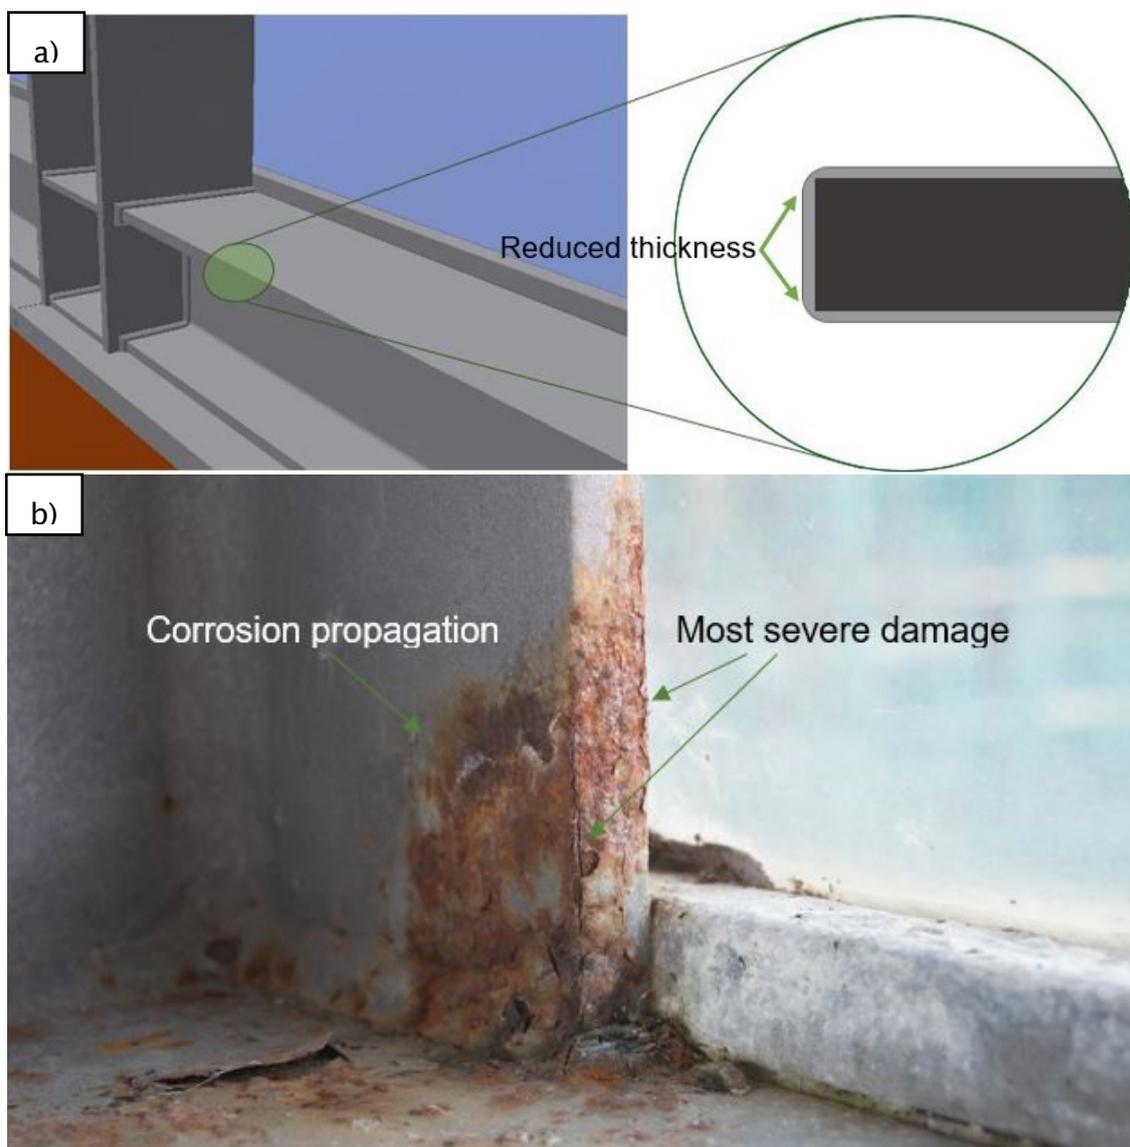
The geometry of the HEB structural steel beams presents 90° edges that provoke discontinuities of the coating thickness as shown in Figure 5a because, during application, the liquefied paint tends to flow away from the acute angles due to surface tension, causing a thinning on the coating. This design mistake affects both horizontal and vertical beam elements.

As a result of this, the 90° edges of the beam act as a weak spot in which the corrosion process tends to start. Figure 5b illustrates the severe damage caused in one of the vertical beam edges of the structure.

Figure 5 (a, b). Corrosion issues in the beam 90° edges

In Figure 5b, it can be appreciated that the most severe damage is localized in the 90° edge of the beam. Moreover, a propagation pattern can be observed, which means that the

corrosion process began at the 90° edge and then proceeded to affect the plain surface of the beam.

All of the exposed 90° edges of the beams should be machined with a 2 mm radius. This action guarantees that a uniform coating layer can be formed during the application and drying processes, as can be seen in Figure 12, thus providing the best possible anticorrosive protection.

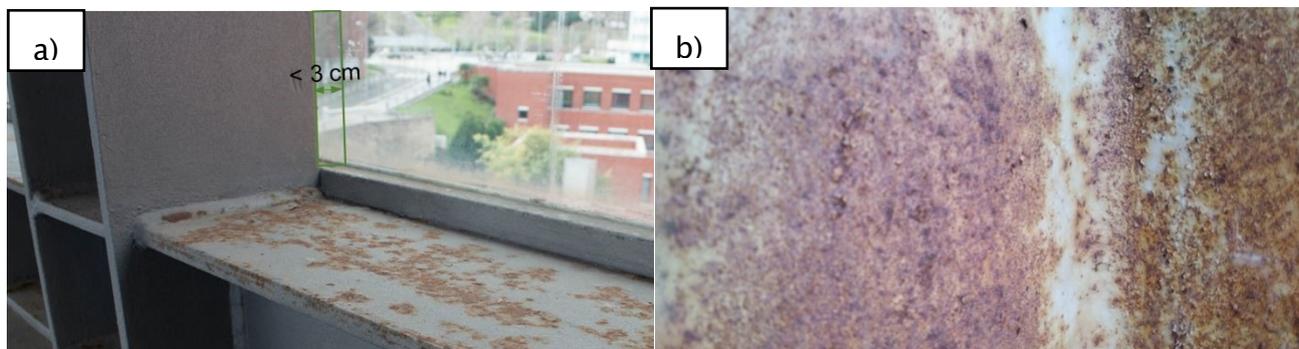
The part of the vertical beams that faces the windows is not accessible for inspection nor maintenance, as the space between the beams and the windows is smaller than 3 centimetres (Figure 6a).

The main problem of this design mistake is that it causes the illusion that the vertical beams of the structure are not affected by corrosion, as the visible part from inside the footbridge appears to be in good condition. Figure 6b shows the posterior part of one of the vertical beams, taken by introducing a camera in the reduced space between the beam and the window, where an advanced state of corrosion can be observed.

Figure 6 (a, b). Corrosion issues in the posterior part of the vertical beams

As with the horizontal surfaces, this problem is not solved by modifying the geometry. The corrosion protection of the areas with lack of access also relies on the proposed coating protocol.

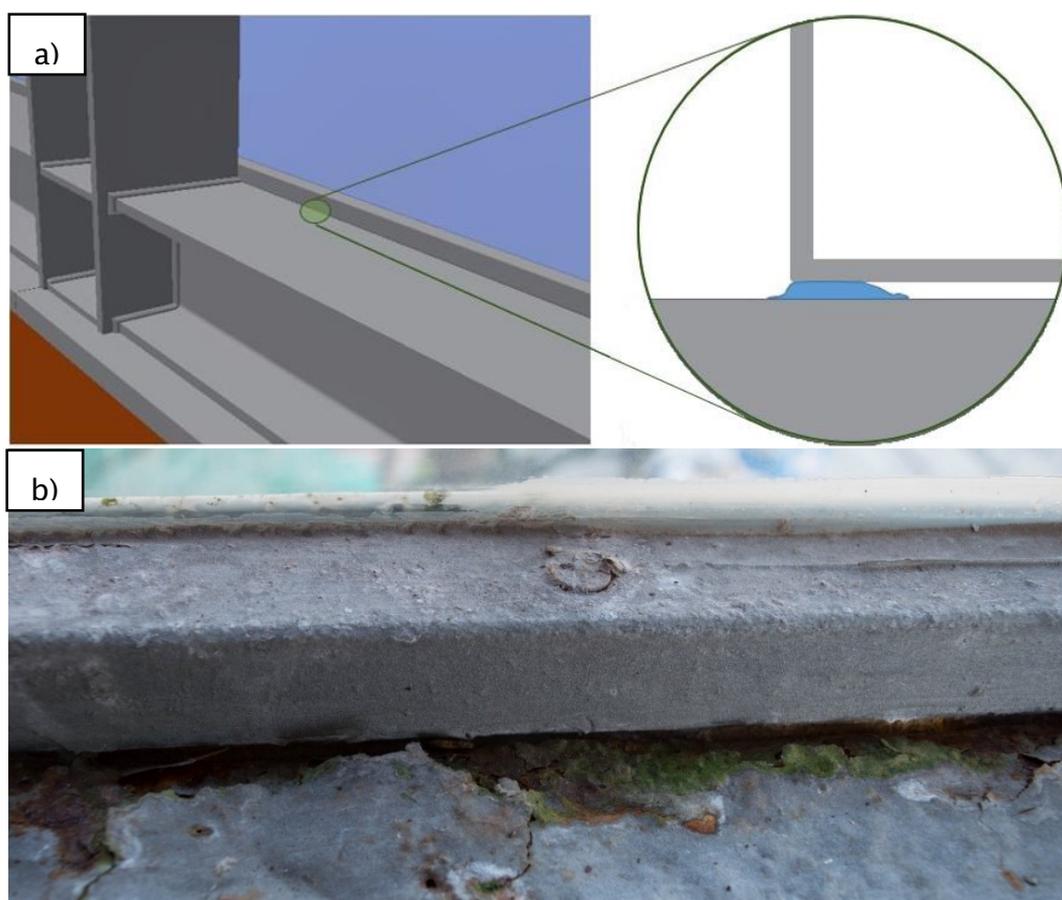
The structure presents crevices, especially in the junction between the beams and the windows steel frames. These crevices provoke retentions of water and moisture (Figure 7a), as they allow liquid penetration and difficult drainage due to the fact that the natural airflow is reduced inside the crevice. Moreover, as the protective paint coating was applied

after assembly, the protective layer is not uniform inside the crevice, as the paint cannot penetrate evenly.

The water retained inside of the crevice acts as the electrolyte for the corrosion reactions, causing deterioration in these areas. In this particular case, the attack in the occluded region is not caused by depassivation and coupling with an external cathode, but merely by water retention. In addition to this, the presence of chloride anions in the occluded regions causes an acceleration of the corrosion processes. Furthermore, when the corrosion process starts inside the crevice, it tends to propagate towards the rest of the beam. This phenomenon has created important damage, as shown in Figure 7b.

Figure 7 (a, b). Corrosion issues in the crevices

All the crevices of the structure should be sealed with a flexible rubber sealant, such as silicone rubber (Figure 13). The exterior part of the profiles (not shown in Figure 13) should also be insulated, creating an impervious chamber below the profile where water, dust, etc. are not able to introduce. This option has been chosen over continuous welding due to the fact that the window frame perimeter cannot be welded as it needs to have a certain movement freedom in order to absorb the thermal expansions.

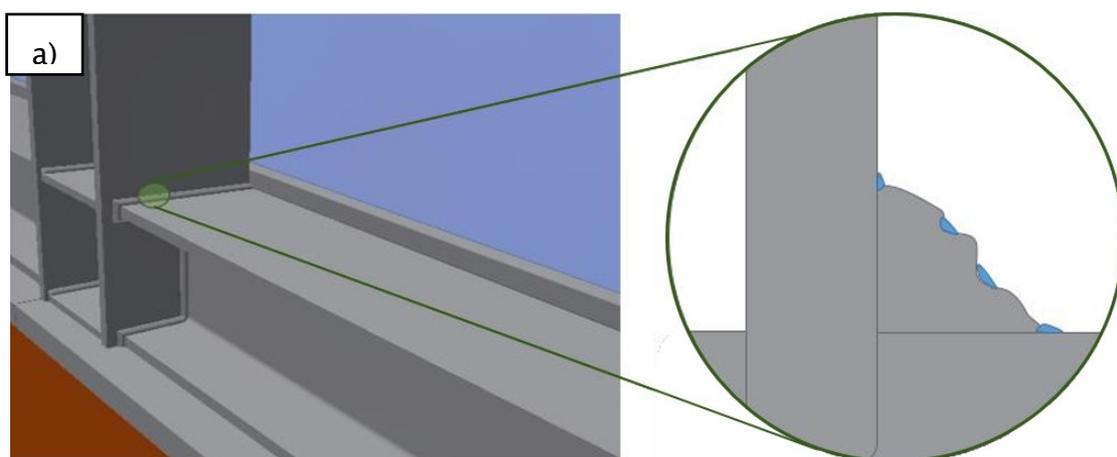
- Firstly, the weld beads introduce geometrical discontinuity on the surface, as they add additional material. Moreover, weld beads often have porous zones (Figure 8a) that allow for liquid retention and favour the formation of not uniform coating layers.
- On the other hand, welding processes signify that the material suffers high thermal stress and, if the cooling process is not controlled, the internal structure of the welded metal is distorted, facilitating the corrosion initiation and propagation.
- Finally, if the weld is not properly cleaned, corrosion might also initiate due to flux or oxide residues.

Figure 8a. Corrosion issues in the weld beads

All of the welds of the structure should be continuous and, if needed, properly machined after application to provide a homogeneous surface (Figure 14) without any significant pores, addition material accumulations nor weld projections, so that a continuous protective coating film can be formed and dirt and water retentions are less likely to occur.

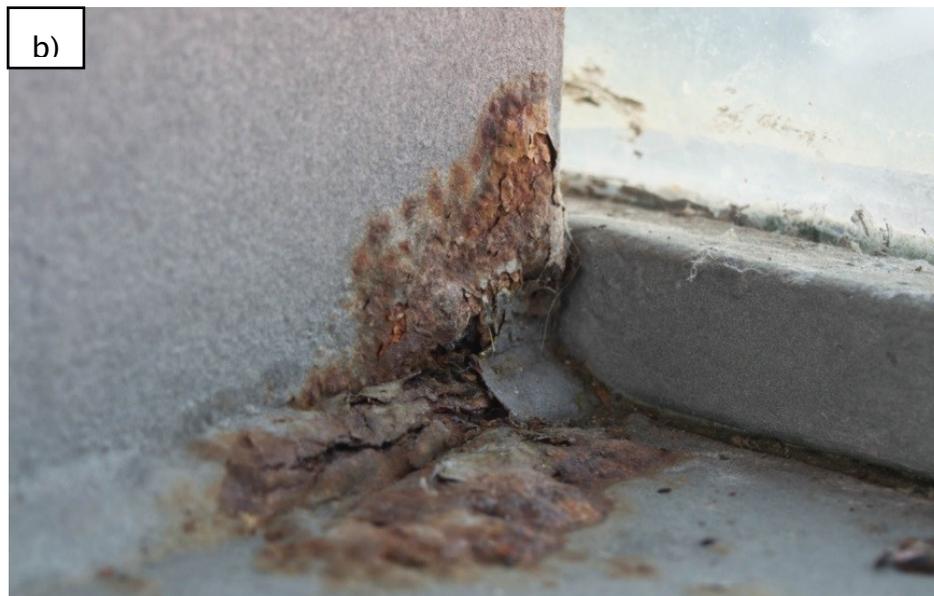
The effect of the combination of the aforementioned processes can be observed in the footbridge structure, where the weld beads show evident signs of corrosion, as can be observed in Figure 8b.

Figure 8b. Corrosion issues in the weld beads

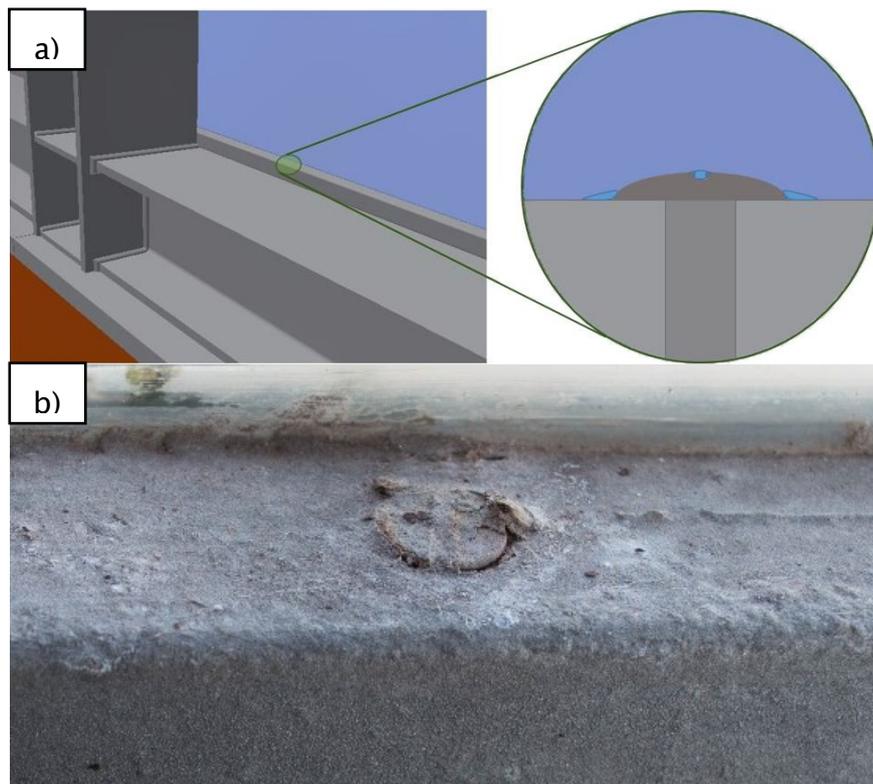
To realize the junction between the structural beams and the window frames, a joining method via bolts was selected. Bolt heads create a geometrical discontinuity in the structure while favouring galvanic corrosion if the material of the joined metals and the bolt is not exactly the same composition wise.

The geometrical discontinuities generate water and dirt retentions (Figure 9a), while hindering the formation of a uniform protective layer. Figure 9b illustrates the discontinuities previously mentioned. Notwithstanding, this design mistake has not shown yet obvious signs of corrosion. Most likely, the root cause for the lack of corrosion products in these points, is that the bolt geometry and material had been properly selected, creating a tight seal and impeding galvanic corrosion.

Figure 9 (a, b). Corrosion issues around the bolts

The bolted joint method is maintained, because even with the actual advanced state of corrosion of the structure, the periphery of the bolts does not show corrosion signs. However, certain points need to be considered:

- The bolt size needs to be selected accordingly to provide a tight seal without protruding over the jointed parts
- The bolt material composition needs to be the same as the one of the joined metals
- The correct installation of the bolts has to be visually verified before the beginning of the coating protocol
