Escuela Técnica Superior de Ingenieros de Caminos, Canales y Puertos.
UNIVERSIDAD DE CANTABRIA, SANTANDER

Final Dissertation

Non-destructive diagnostics for timber structures in historic buildings: Investigation methods and testing tools

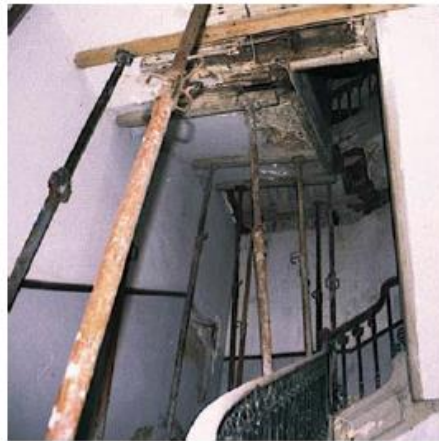
Figure 1 – Rotten Timber Structure with Safety Propping (Cruz, et al., 2015).

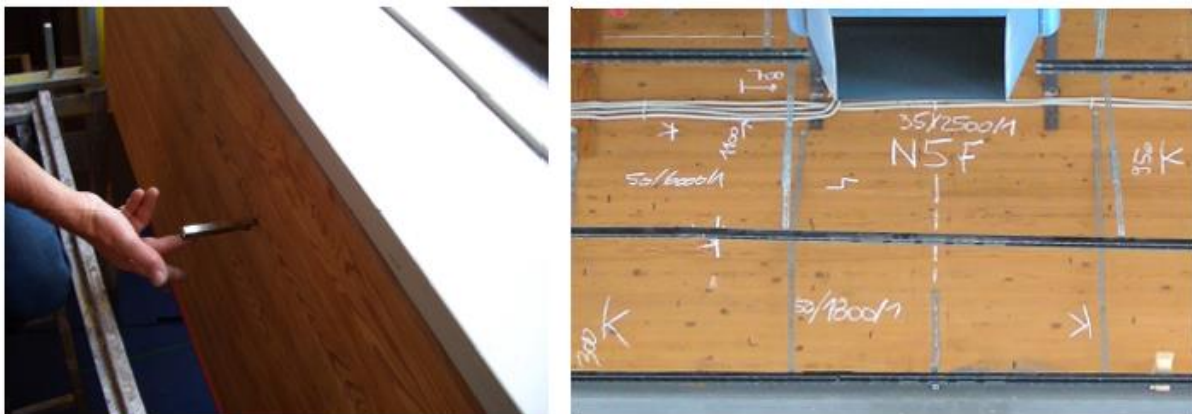
The main purpose of this method is to identify, locate and document vital parts of a structure and investigate the material quality. For example, cracks, surface deterioration, decay or general external damage can be detected and marked as shown in the figure below. Through the visual inspection, the further procedure can be planned in accordance to the accessibility of structural elements, material quality and general state/stability of the structure.

Figure 6 - Example of Crack Measuring; Example of Crack Mapping (Dietsch, Philipp, & Heinrich, 2011).

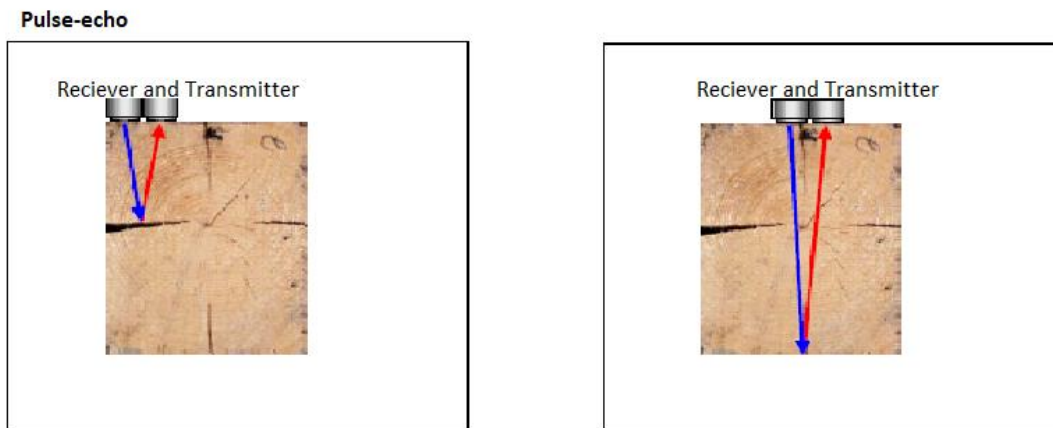
The other ultrasonic based method is the Pulse-echo method. As the name indicates, it operates by sending an impulse and recording the echo of the transmitted sound waves (Hasenstab, 2006). Thereby, transmitter and receiver are located on the same side of an element and once the waves reach the end of an element, they are reflected back and recorded by the receiver. However, if a defect lies within the path, the waves are reflected earlier, indicating a crack or cavity for example. According to Tannert, Kasal & Anthony (2010) a clear back wall echo can therefore be seen as an element without defects. This is also very helpful as “using calibrated values, it is possible to determine the thickness of beams where the back wall is not accessible and to get an insight on the inner structure of elements.” (Tannert, et al., 2010, p. 2).

Figure 9 - Schematic of the Pulse-echo Method (Baron, 2009).

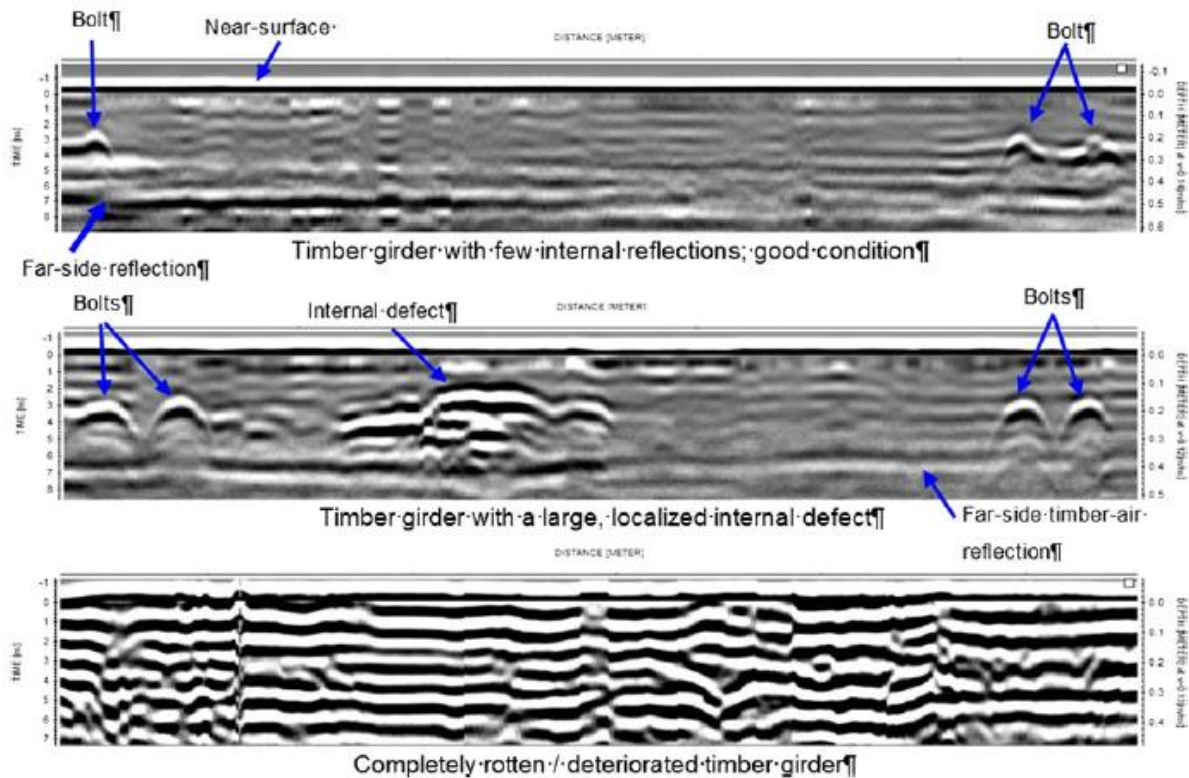
Reflections are caused when the waves encounter material interfaces of different dielectric constants (Riggio, et al., 2013). According to Riggio et al. (2013) these can be a contrasting interface between sound wood and an air-or water-filled void, rotten timber, hidden elements such as steel bolts or the backside of the object investigated. The ground penetrating radar produces 2D radar images that are developed from a series of measurements where the system “records the two-way travel time and amplitudes of signal reflections as a function of travel time.” (Ullberg, 2011, pp. 7-8).

Figure 12 – Radar Image Showing Several Damage Patterns (Riggio, et al., 2013).

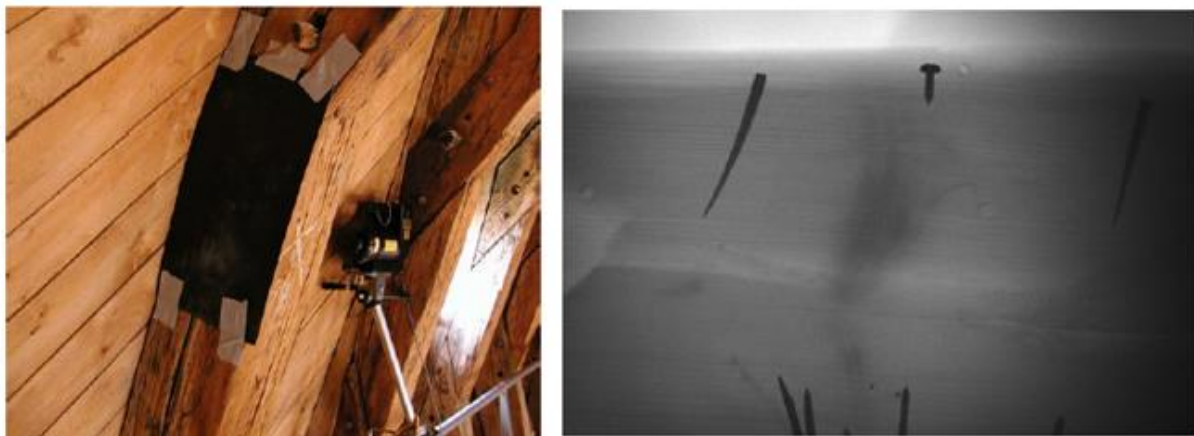
Similar to X-ray scans that are used in medicine to detect injuries such as fractures, when used to assess a building this technique can detect inner damages or irregularities such as deterioration, metal objects, decay and disruptions of the grain structure caused by insects, drill holes or voids (Löwenmark, 2009). Even growth rings can be visualized with X-rays as the low mass attenuation of wood allows the use of low energy levels that produce high resolution images and thanks to modern computer programs, images can be further enhanced to even distinguish between subtleties that are otherwise only detectable through destructive testing (Kasal, 2010). Through an analysis of the results, the material's density as well as the overall structural quality can be estimated and the method can easily be used in-situ due to modern, small and handy X-ray devices as shown in the figure below (Nowak, 2013).

Figure 15 – Experimental Setup of X-ray Scanning (left) and Captured Image of a Wooden Beam with Metallic Elements Inside (right) (Riggio, et al., 2013).

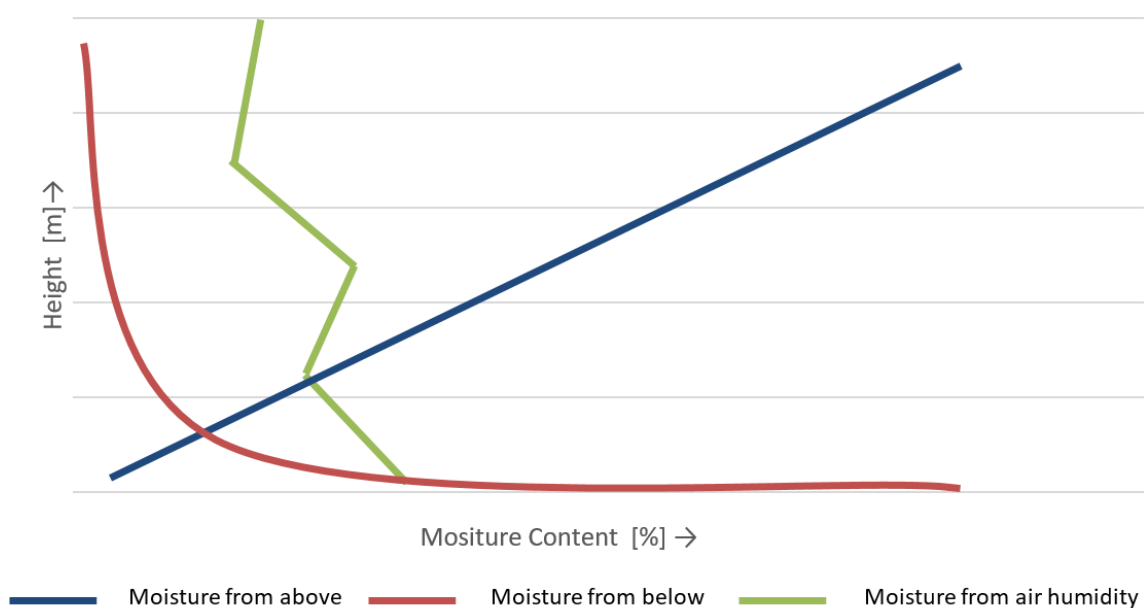
First and foremost, the moisture content of the overall structure and individual elements will be determined. Thereby, one can identify critical areas and members that contain a high moisture content and thus could be targeted by decay from insect or fungi. However, through the analysis of the gained results and by measuring the air humidity within the building, the source of moisture, especially if excessive, can be detected as well. Therefore, vertical elements should be measured at different heights to detect rising dampness, condensation or infiltration. Possible sources of moisture can vary as the graph below shows exemplary.

Figure 21 – Exemplary Depiction of Different Moisture Causes.

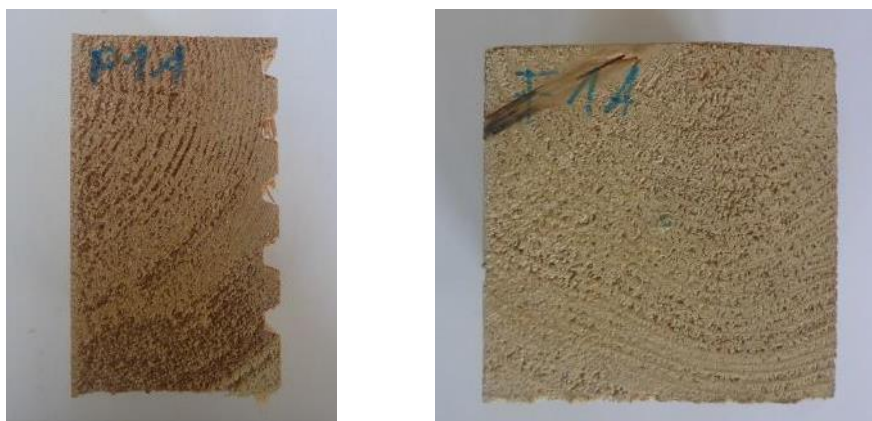
For this laboratory procedure, three samples of pine and three samples of fir were used. The fir samples were cubes with a side length of approximately 10cm and the pine samples were cuboids with the dimensions 10x10x5cm. Thereby, the pine samples had one square surface with rills milled into it as it can be seen in the pictures below. All other samples and sample sides are documented in the annex.

Figure 1 & 2 – View of Sample Cross Sections with Pine on the Left and Fir on the Right.

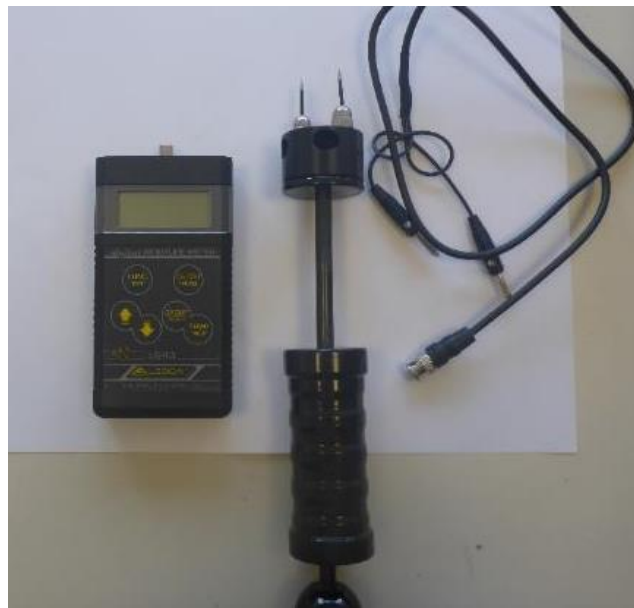
The moisture content of the samples was measured using the resistance method. The moisture content is an important property of wood as it can indicate the presence of biological form fungi or insect as these prefer wood with a high moisture content. The resistance method uses a moisture meter that contains two pin-type electrodes, in between which, the electrical resistance is measured to estimate the moisture content. The equipment used in this study was the “Logica LG43” model which contained a small computer system, a gadget for the electrodes and connection cables. The electrodes-holding gadget was also used for driving the electrodes into the wood, using the metal handle as a hammer. Electrodes in this model can be screwed onto the gadget and come in different lengths and isolation type. Before the start of tests, the species of the used samples must be known as the equipment divides different tree species into three groups due to the difference of electrical resistance between species.

Figure 4 – Equipment of the Logica LG43 with Computer, Gadget and Connection Cables (left to right).

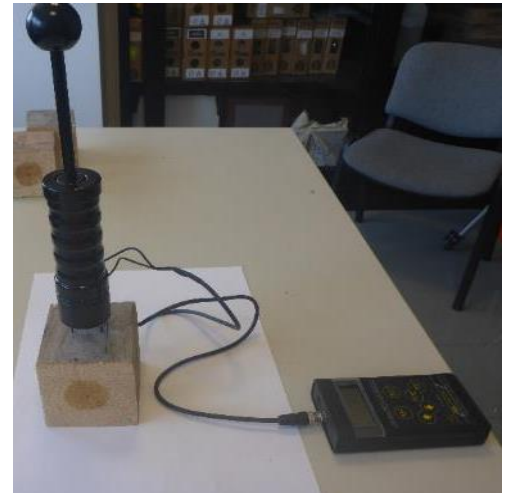
Figure 5 – Measuring of Moisture Content of Fir Sample.

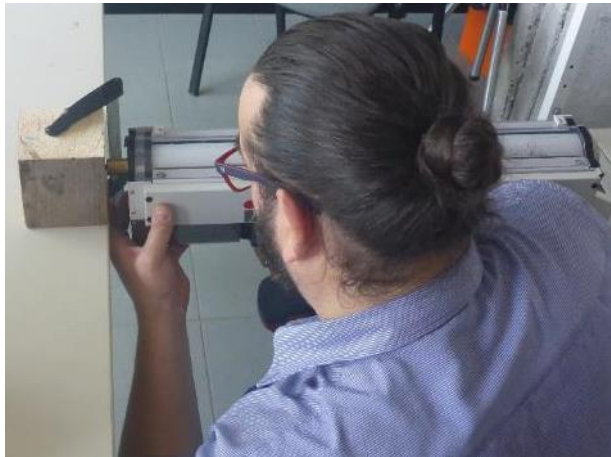
1. The middle of the sample's surface was marked with a dot, showing the starting point of drilling.
2. The resistance diagram paper was labeled, indicating species, sample number as well as penetrated surfaces and was carefully put in its place.
3. The drill was reset, placed on the starting point perpendicular to the surface and drilling was set to clockwise.
4. Drilling was started with a constant rotation speed and advance, making sure that the drill remained in a stable position.
5. Once the drill penetrated the back wall of the sample, the drilling was stopped, set to counterclockwise and retrieved with a slow advance but high rotation speed.
6. Lastly, the resistance diagram sheet was removed and placed on top of the sample and recorded via photograph while showing the drilling path with the correlated resistance.

Figure 6 – Resistance Drill in Use.

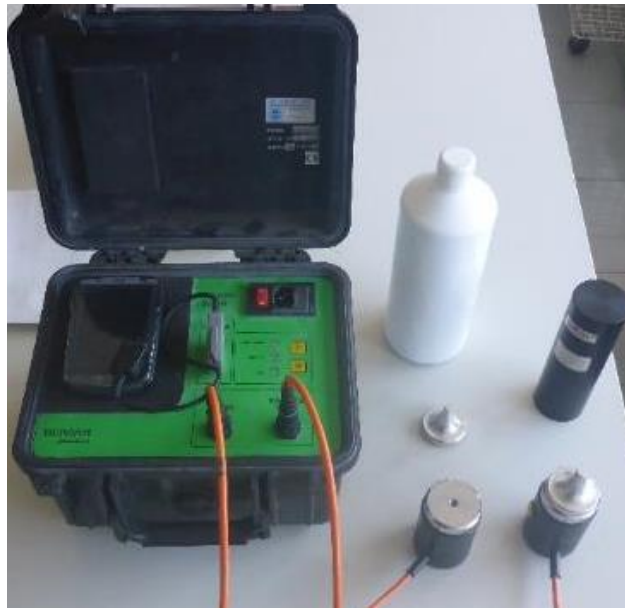
all samples were measured accurately and the dimensions were used with a computer software for the results. Each sample was tested with the ultrasonic technique. Thereby, the fir samples were tested in all three directions; in grain direction, perpendicular and tangential to it. The pine sample were only tested tangential and with fiber orientation due to the milled surface. Each test was performed with longitudinal waves and five impulses were transmitted for each measurement.

Figure 7 – Ultrasonic Equipment with Bottle of Coupling Agent.

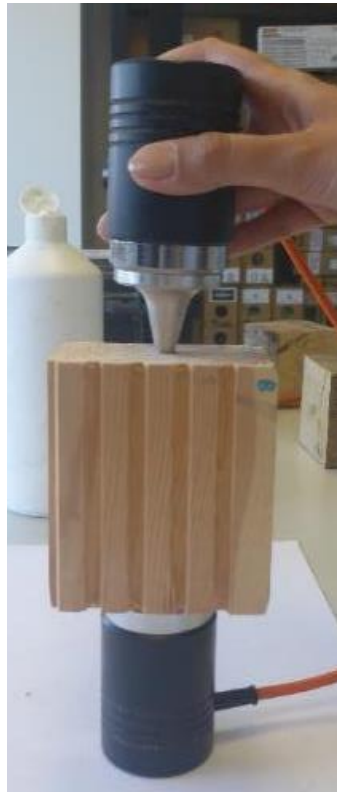
1. The equipment was connected, turned on and the sample thickness was entered into the computer.
2. The receiver surface was applied with some coupling agent and the sample was placed centrally on top of the receiver.
3. Coupling agent was applied to the tip of the transmitter and it was placed in the middle of the sample's top surface.
4. Once the transmitter was placed, the ultrasonic unit was turned on and started sending impulses.
5. Through the computer, the live data can be seen and after five impulses the ultrasonic unit was turned off again.
6. The results of the 5 impulses were saved, labeling species, sample number and test direction.
7. After the results were saved, the history of results was cleared and the next test began, repeating the procedure.

Figure 8 – Experimental Setup of Ultrasonic Test.

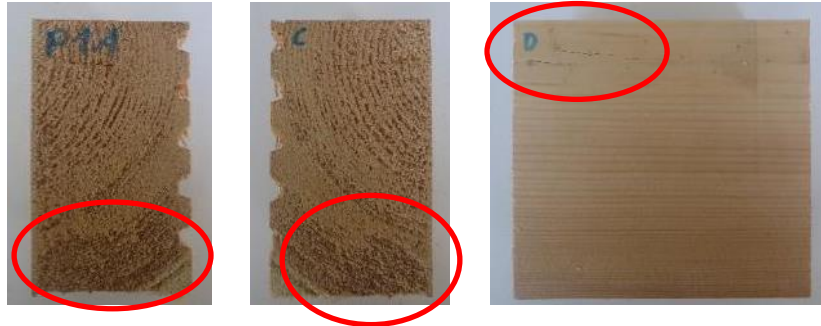
The sample showed no strong signs of defects or irregularities, however, the surfaces A and C that show the cross section of the tree, appeared to be more porous on the outer sapwood area (see figure below). Other than that, the D surface showed small cracks in the corner towards the surfaces C and E. The cracks appear to be small and in direction of fiber yet could reach further inside the sample.

Figure 9 – 11 – Sample Surfaces A, C and D (left to right) with Visible, Suspicious Areas Marked.

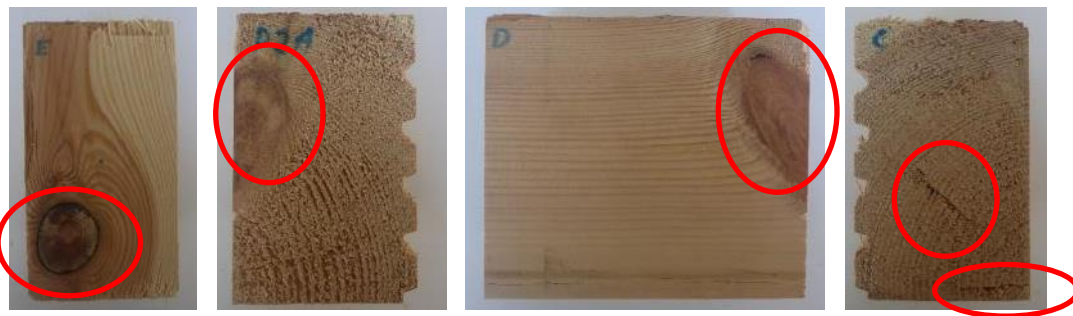
Contrary to the first pine wood sample, the second one showed natural irregularities and defects on all but two surfaces (B and F). The E surface showed a large knot that was also present on the surfaces A and D as its orientation was towards these surfaces. The other cross-section surface showed no knot but two cracks, both perpendicular to the orientation of fibers.

Figure 11 – 14 – Sample surfaces E, A, D and C (left to right),

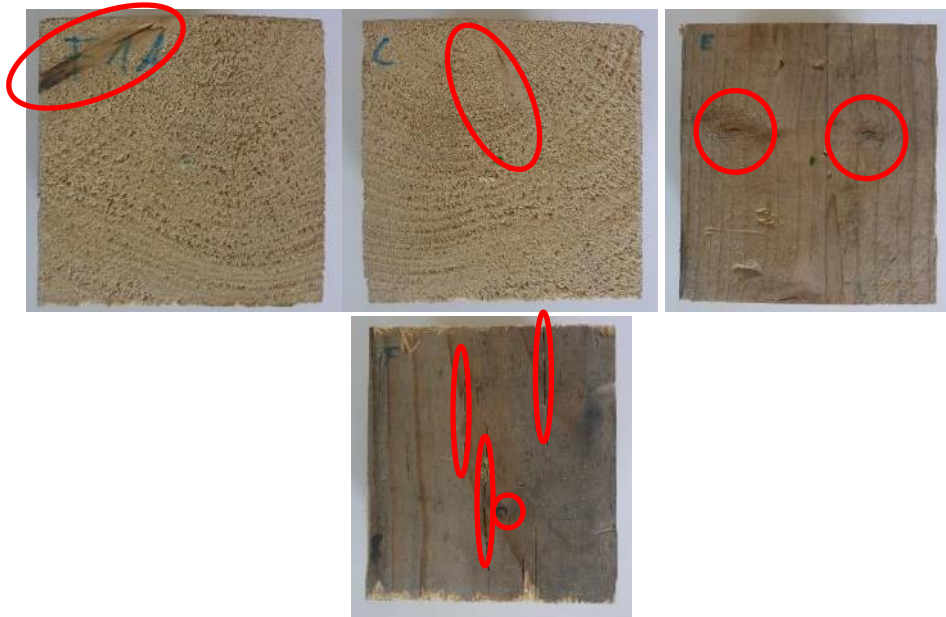
Figure 17-20 – Sample Surfaces A, C, E and F.

Two cracks could be seen on the two-cross section surfaces A and C. The surfaces E and F showed little cracks and knots which are expected not to reach far inside the sample. Small dents were seen on the remaining surface B and D but they seemed not to reach further to the interior.

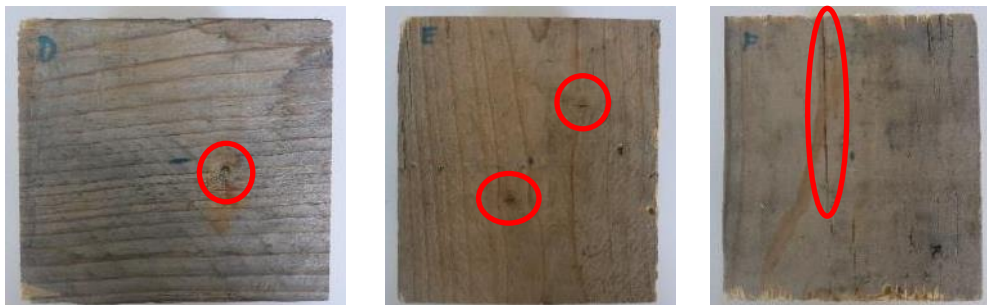
Figure 21-23 – Sample Surfaces D, E and F.

The second fir sample only showed minor noticeable characteristics. Surfaces D and E contained small knots and surface F had a crack in grain direction. However, due to the small size of all findings, no major effects are expected from these characteristics.

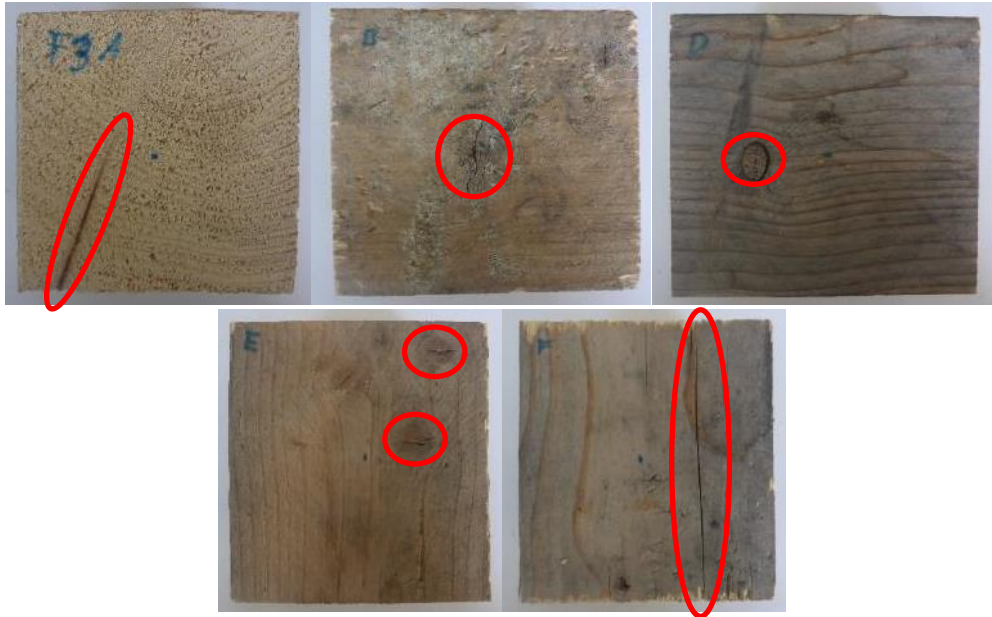
Figure 24-28 – Sample Surfaces A, B, D, E, F.

Several saliences were found on the surfaces of the last fir sample. Surface A showed a large crack perpendicular to the fiber direction and surfaces B, D and E showed one or several knots. Lastly surface F contained a crack in the direction of grain and reaching almost across the whole length.

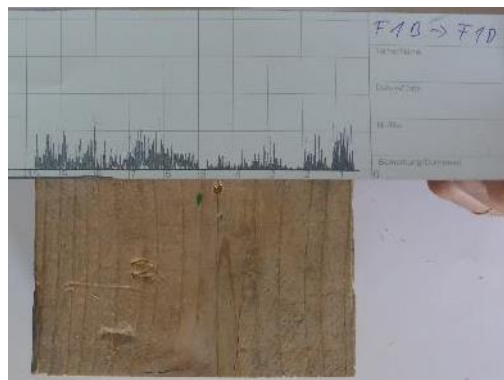
Figure 30 - Resistograph Diagram of Fir Sample 1 with Drilling Direction from Surface B to D.

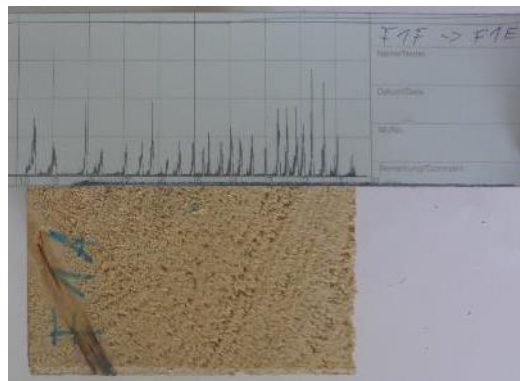
Figure 31 - Resistograph Diagram of Fir Sample 1 with Drilling Direction from Surface F to E.

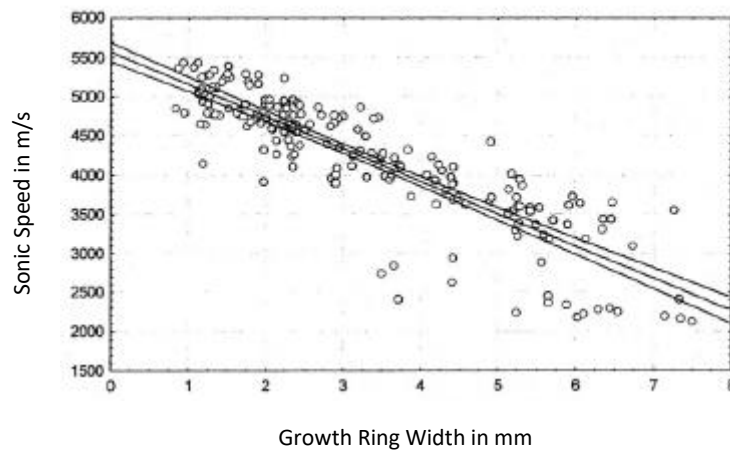
Figure 34 – Influence of Growth Ring Width on Sonic Speed for Spruce (Hasenstab, 2006).
