FACULTAD DE MEDICINA
UNIVERSIDAD DE
CANTABRIA

TRABAJO FIN DE GRADO

Review of the problem of PIP breast implants

(Revisión del problema de las prótesis PIP)

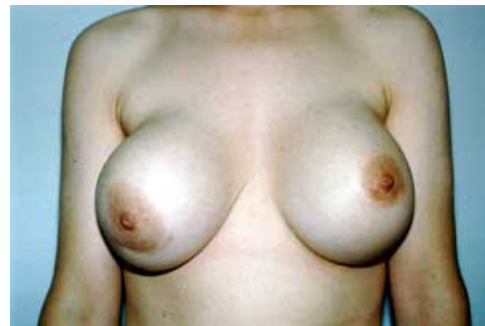
Image 1: Deformity of the right breast caused by capsular contracture.

- b) **Capsular contracture:** The body creates a collagen capsule around breast implants, or any foreign object that is inserted into the body (such as pacemakers or orthopedic prosthesis) to isolate the object from the rest of the body. Capsular contracture occurs when this capsule begins to thicken and compress the implants, causing pain and deformities to the patient¹⁰.

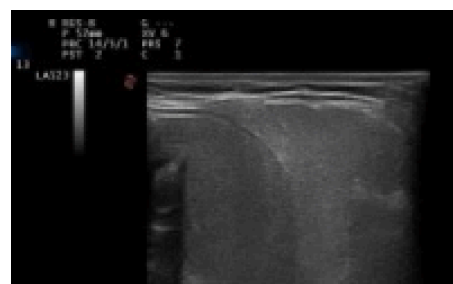
Image 2: Siliconome seen with US (note the change of phase in the material)¹.

- d) **Siliconomes:** Silicone accumulates in surrounding tissues and lymph nodes (especially axillary nodes, but also internal mammary or even supraclavicular nodes). This happens in case of leakage of the filler material. These are relatively frequent, with up to 67% in some cases⁶.

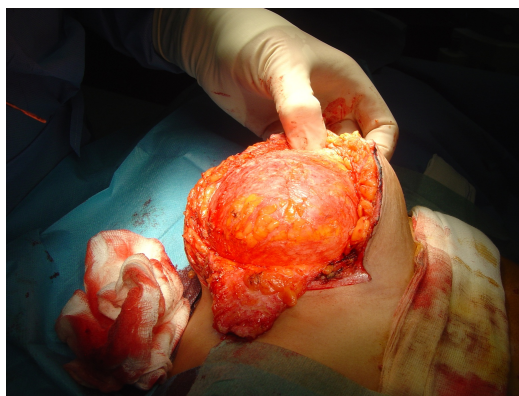
Image 11: Intraoperative view of prosthesis and capsule.

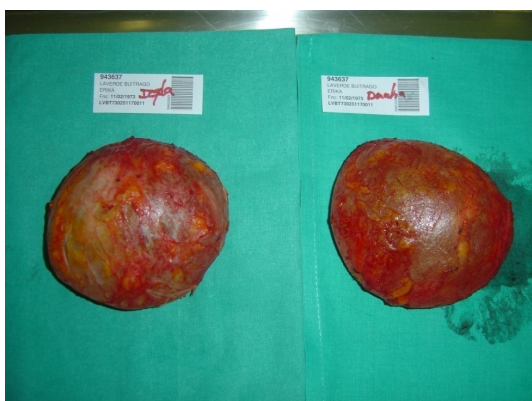
Image 12: Prosthesis with capsules.

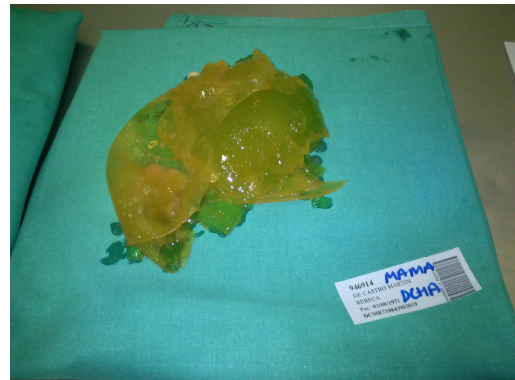
Image 18: Ruptured implant after explantation.

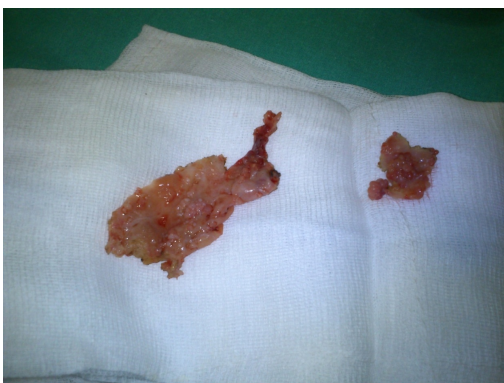
Image 19: Surgical piece, which was informed by pathology as: Synovial metaplasia, fibrosis, Xanto-granulomatous reaction. Due to leaked silicone from implants.
