The Impact of Design on Material Corrosion: An Illustrative Example

In this paper, the synergy between corrosion and design is studied via an illustrative example: a relatively new, large footbridge, located in the north of Spain, which shows evident signs of corrosion.

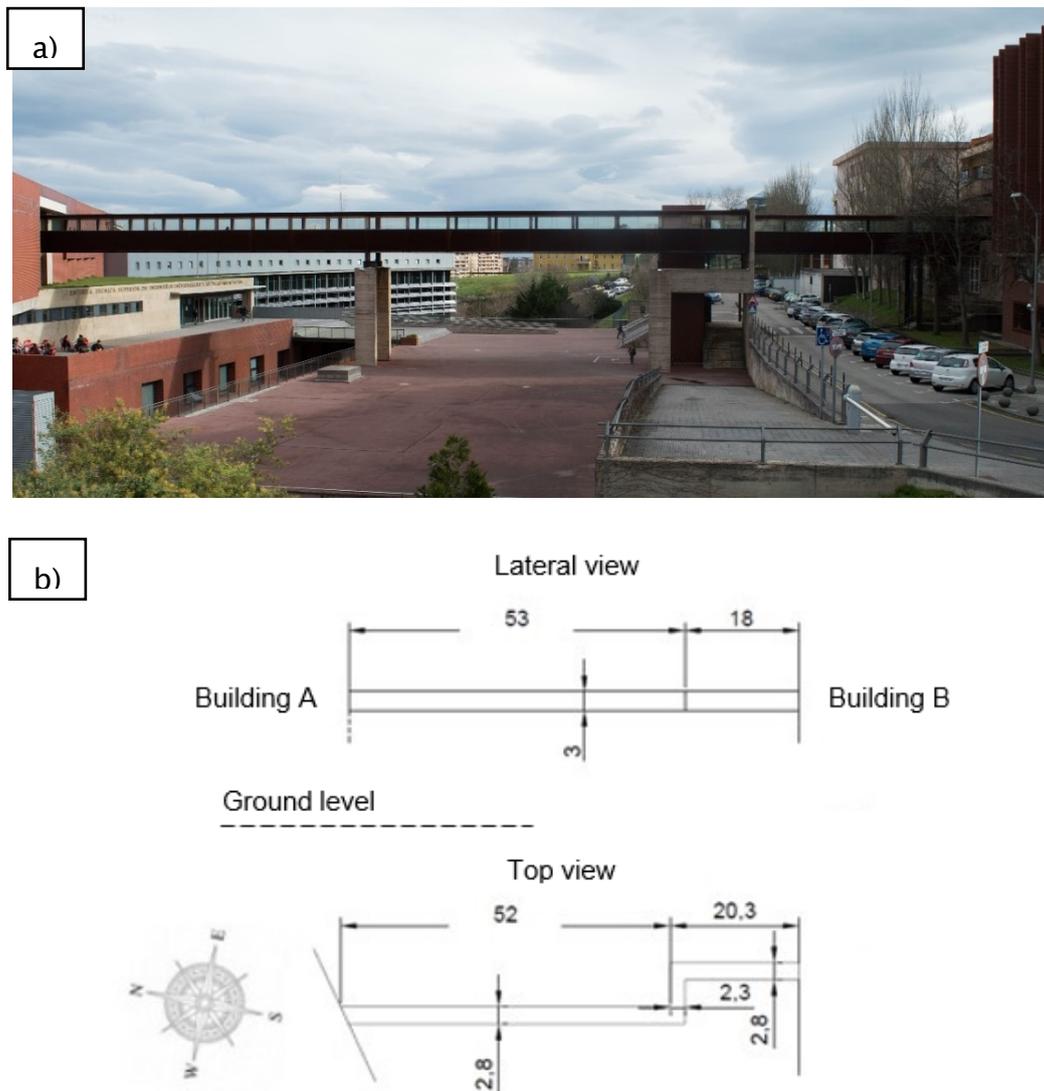
Figure 1 (a, b). Studied footbridge exterior view and dimensions

In this paper, only the interior part of the footbridge is studied, since the exterior is not possible to evaluate appropriately without the use of cranes or other elevation methods, which are not available to the authors at the moment of the study.

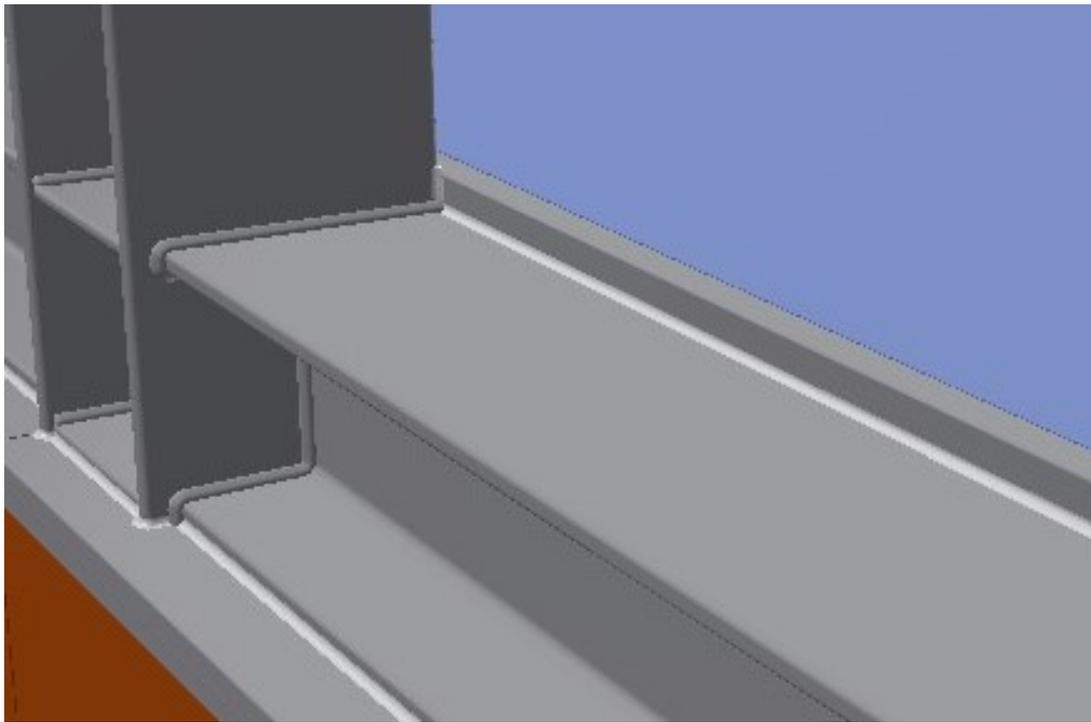
Figure 10. Overview of the proposed design

A more corrosion resistant design of the footbridge structure is proposed according to the state of the art, solving the design mistakes. Not only does this proposed design show that there is no need for pompous measures to be taken in order to increment the service life of the structure, but also that the necessary measures are totally compatible with the conceived design, not modifying the designer initial approach.

Figure 10 illustrates the proposed design. The modifications in respect with the actual design are addressed in the following subsections.

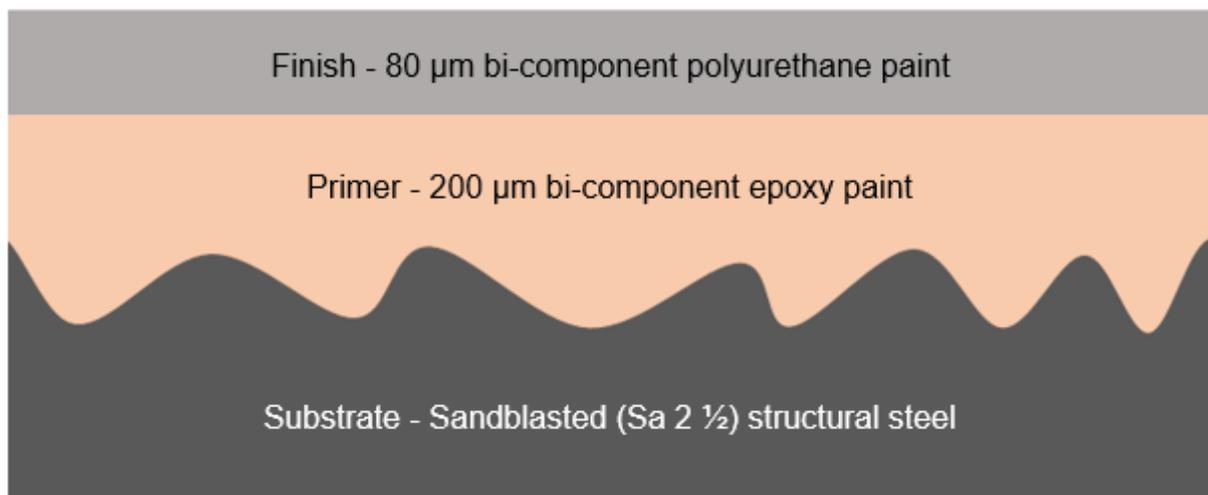
Figure 11. Scheme of the proposed protective paint system

The proposed coating protocol, designed with the help of the recommendations of one of the most respected coating manufacturers, is depicted in Figure 11.

This high quality coating protocol ensures, according to the manufacturer, at least 15 years before the first maintenance in a heavy-duty atmosphere. A long lasting coating protocol has been selected taking into consideration the actual state of lack of maintenance and the fact that some of the design mistakes cannot be solved modifying the geometry of the structure.

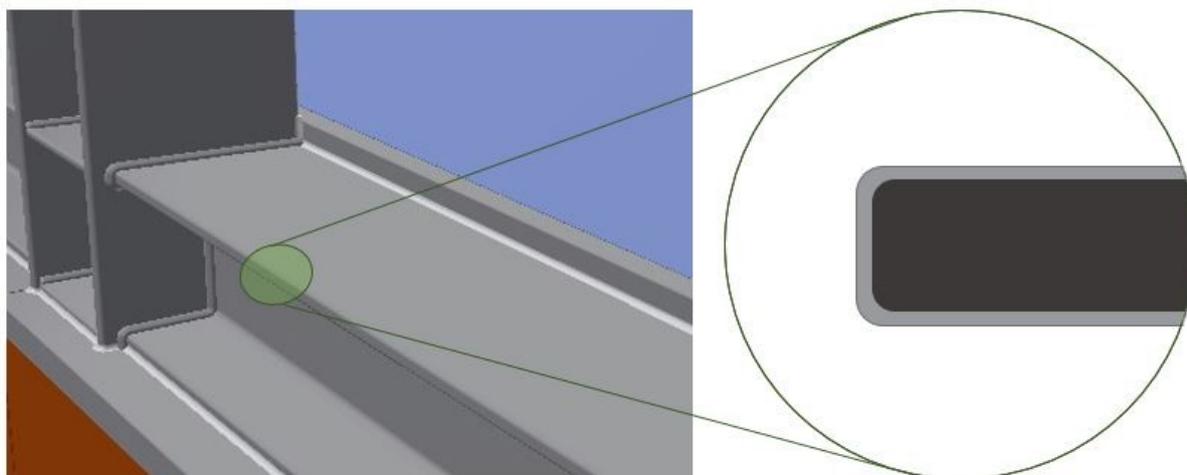
As a result of this, the 90° edges of the beam act as a weak spot in which the corrosion process tends to start. Figure 5b illustrates the severe damage caused in one of the vertical beam edges of the structure.

In Figure 5b, it can be appreciated that the most severe damage is localized in the 90° edge of the beam. Moreover, a propagation pattern can be observed, which means that the

corrosion process began at the 90° edge and then proceeded to affect the plain surface of the beam.

Figure 12. Proposed rounded angle design of the beam edges

All of the exposed 90° edges of the beams should be machined with a 2 mm radius. This action guarantees that a uniform coating layer can be formed during the application and drying processes, as can be seen in Figure 12, thus providing the best possible anticorrosive protection.

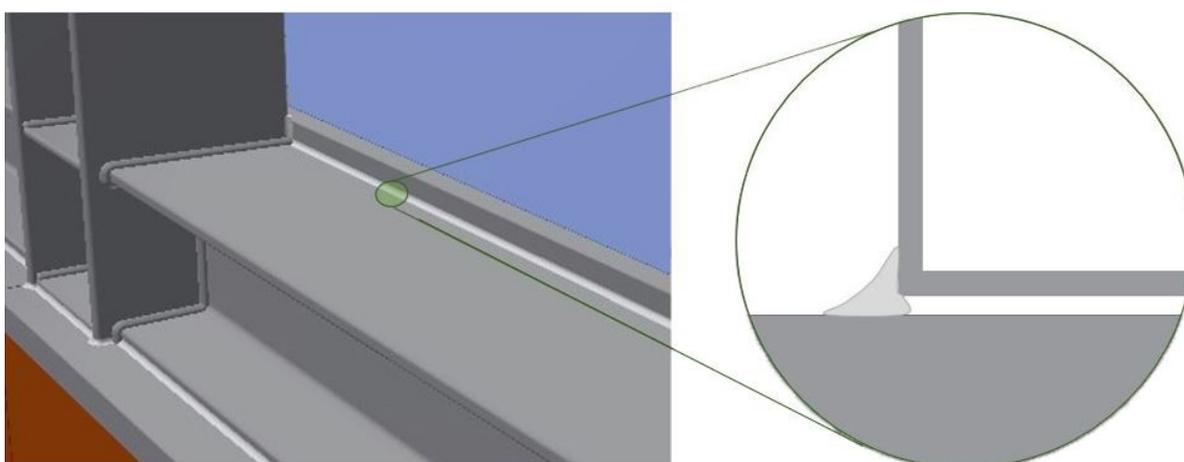
The structure presents crevices, especially in the junction between the beams and the windows steel frames. These crevices provoke retentions of water and moisture (Figure 7a), as they allow liquid penetration and difficult drainage due to the fact that the natural airflow is reduced inside the crevice. Moreover, as the protective paint coating was applied

The water retained inside of the crevice acts as the electrolyte for the corrosion reactions, causing deterioration in these areas. In this particular case, the attack in the occluded region is not caused by depassivation and coupling with an external cathode, but merely by water retention. In addition to this, the presence of chloride anions in the occluded regions causes an acceleration of the corrosion processes. Furthermore, when the corrosion process starts inside the crevice, it tends to propagate towards the rest of the beam. This phenomenon has created important damage, as shown in Figure 7b.

Figure 13. Proposed crevice sealing method

All the crevices of the structure should be sealed with a flexible rubber sealant, such as silicone rubber (Figure 13). The exterior part of the profiles (not shown in Figure 13) should also be insulated, creating an impervious chamber below the profile where water, dust, etc. are not able to introduce. This option has been chosen over continuous welding due to the fact that the window frame perimeter cannot be welded as it needs to have a certain movement freedom in order to absorb the thermal expansions.

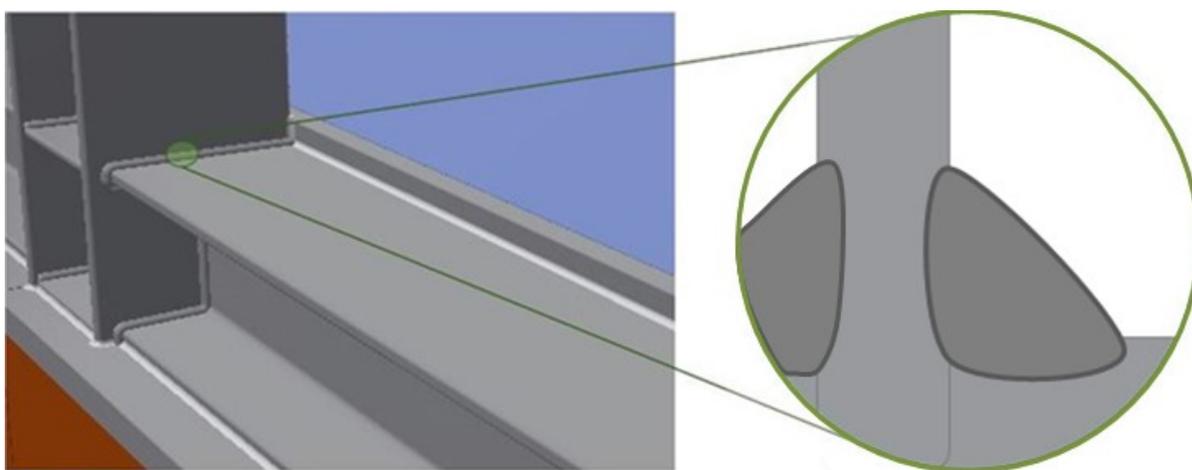
Figure 14. Proposed weld bead design

All of the welds of the structure should be continuous and, if needed, properly machined after application to provide a homogeneous surface (Figure 14) without any significant pores, addition material accumulations nor weld projections, so that a continuous protective coating film can be formed and dirt and water retentions are less likely to occur.
